# Africa Hall - Rehabilitation & Heritage Preservation Detailed Design for the United Nations

## Project Profile

## EXECUTIVE SUMMARY

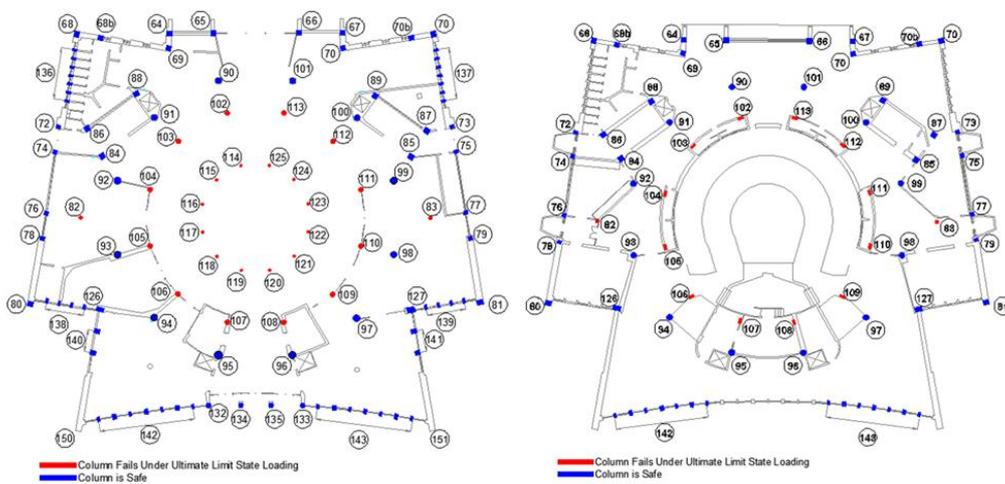
Figure 2 – Columns: Structural Design Assessment

Columns were evaluated for ultimate limit-state vertical and lateral design loads (including seismic forces). With incomplete record drawings, several assumptions based on current international design standards and known local construction practices were adopted. Analysis indicated that 28 of the ground floor columns and 14 first floor columns fail to accommodate ultimate limit state

loads as illustrated in Figure 2. In addition, the majority of the columns failed to meet the minimum steel reinforcing detailing requirements required by current international standards.

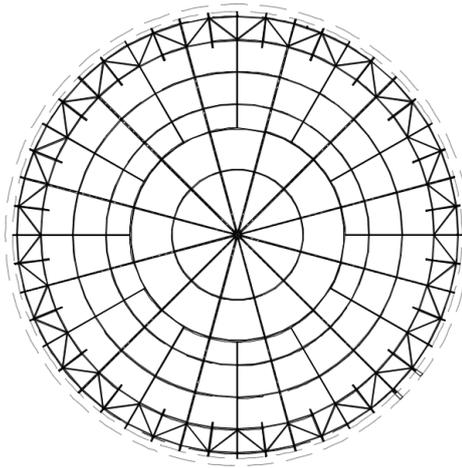
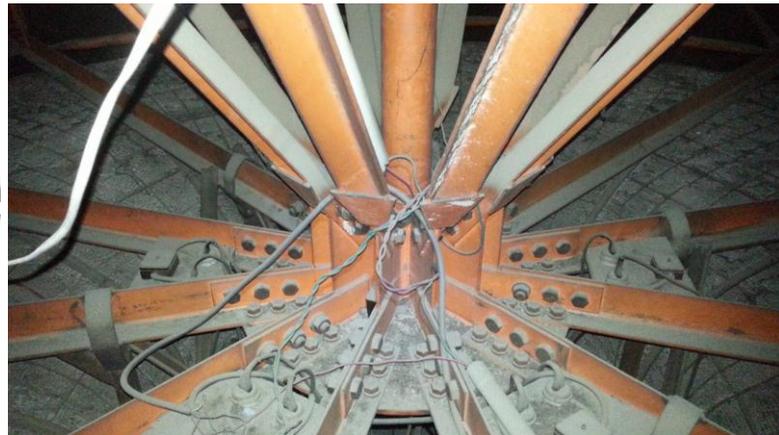
Figure 3 - Roof Truss Structure

The roof system of the Africa Hall building consists of cylindrically arranged trusses which span up to 34m. Refer to Figure 3 and cover-page Figure 6 (1959 "As-Built" Drawings extract). Analysis of 'as-constructed' sections sizes and connections indicate adequacy with respect to ultimate actions including seismic and wind loadings.

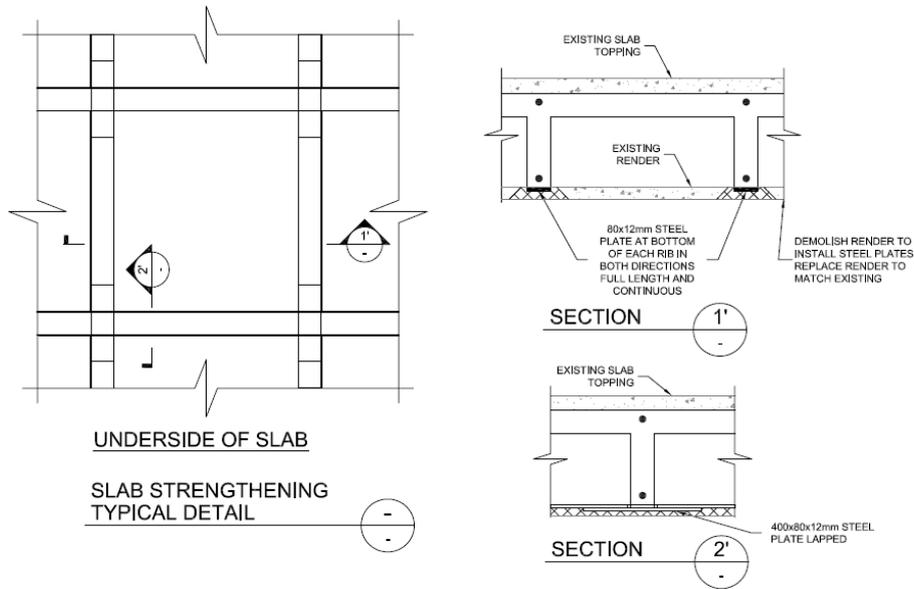
**Figure 4 - Slab Strengthening Documentation Extract**

Documentation extracts of our proposed strengthening to columns, beams and a slab is provided in Figures 8, 9 and 4 respectively (refer to entry cover page for Figures 8 & 9).

Although CFRP is a common practice low-profile strengthening option available in many countries, this option was considered too expensive and too much of a risk given the lack of materials and local contractor experience within the region. Another option investigated was to wrap deficient structural elements within a reinforced concrete sleeve to enhance structural capacity, however this was perceived to create issues relating to spatial planning and end-use. Considering all factors involved the addition of steel plate sections to the perimeter of columns and beams was deemed to be the favoured strengthening approach.

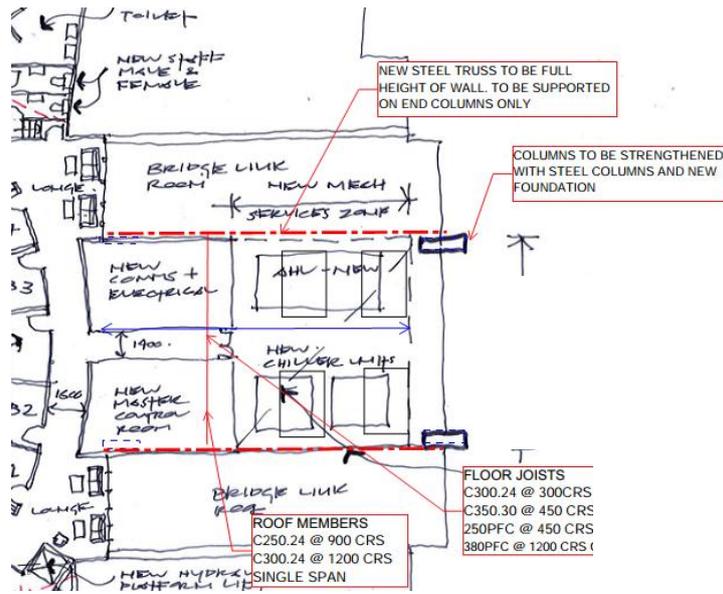
**Figure 5 - Link Structure Sketch**

Part of the proposed refurbishment works for Africa Hall included addition of a new floor, to be constructed on top of the 34m level 1 link bridge, in order to provide state-of-the-art audio-visual facilities and plant deck for new mechanical ventilation. Our challenge was to minimize additional load to existing link bridge, and to minimise loading of other existing structure. A long-span truss structure was detailed to span independently between the two adjacent buildings.

The proposed truss structure comprises T-Section top and bottom chords, and equal angles for the web elements. The floor structure of the new plant deck was specified as lightweight steel C-Section members, supporting economy and constructability.
